RETAINING SEA WALL

CASE STUDY THAT CAN BE APPLIED WORLD-WIDE

VANCOUVER, BC

OCTOBER 2008

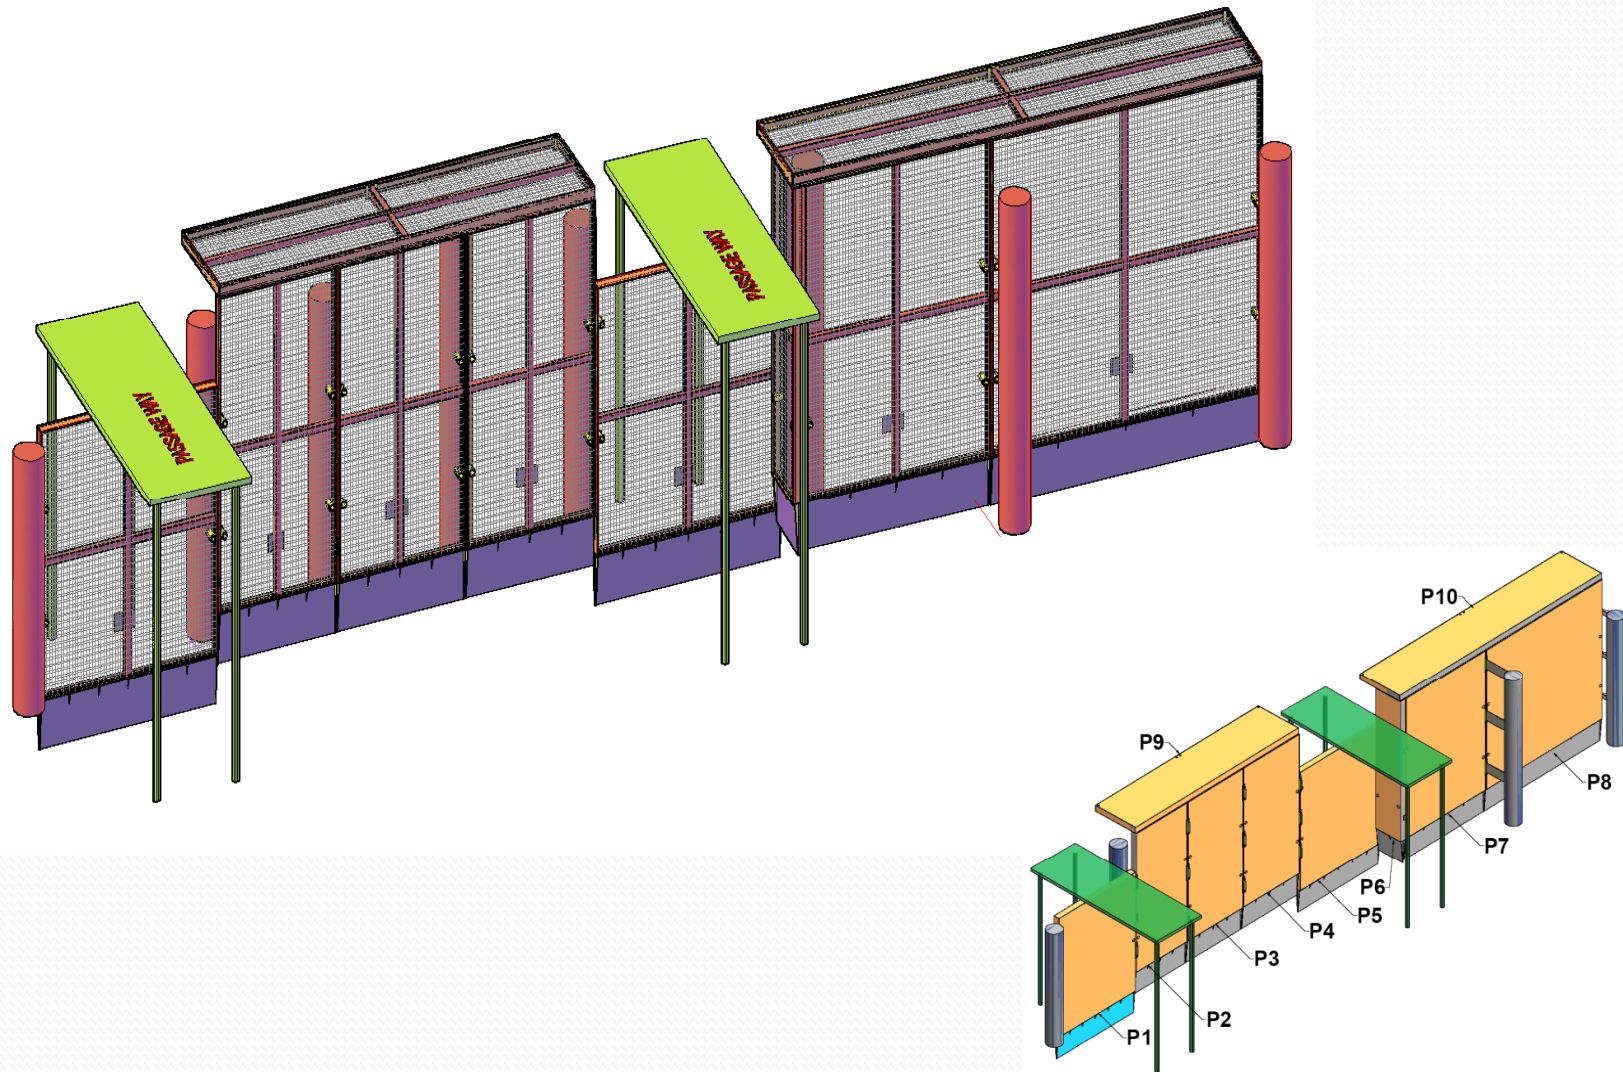
RETAINING SEA WALL – ISOMETRIC VIEW ILLUSTRATING THE 3-DIMENSIONAL PANEL ASSEMBLY

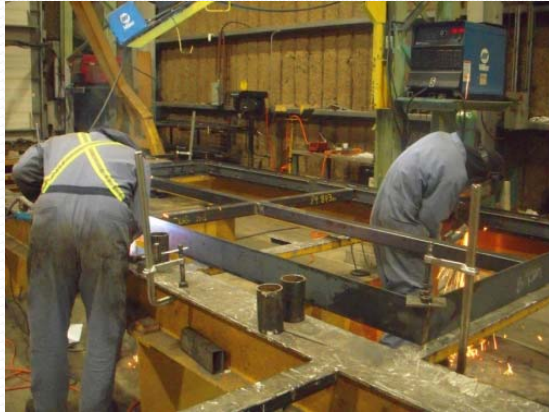
IHI HEAVY DUTY STEEL FRAME PANEL

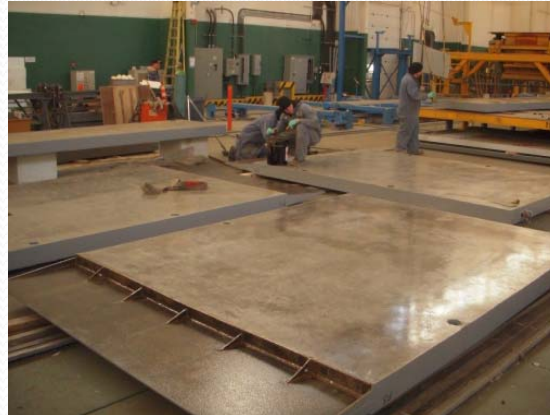
FINE FINISHING OF THE 12,000 PSI
CONCRETE IHI PANEL

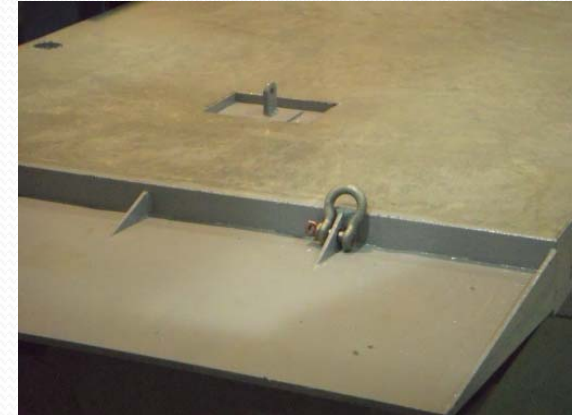
COATED STEEL SECTION TO BE EMBEDDED
UNDER WATER

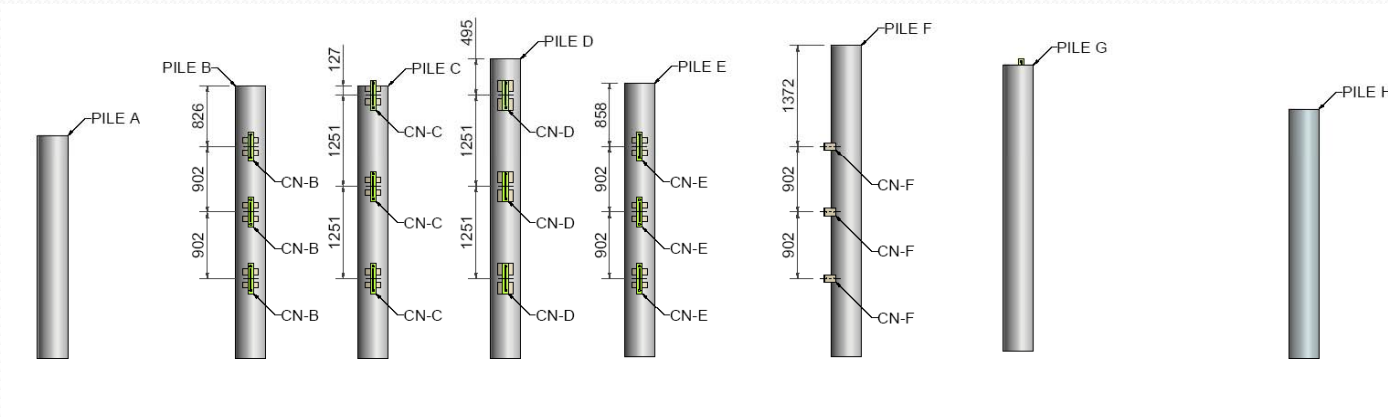
ELEVATION OF PILES LAYOUT WITH WELDED BRACKETS

PILES IRREGULARLY SPACED TO FIT OLD EXISTING INFRASTRUCTURE. IHI OPTIMIZED THE PANEL SIZE IN LAYOUT TO MAKE THE SEA WALL LOOK GOOD AND MAINTAIN ITS MAXIMUM STRENGTH AFTER INTEGRATING TOGETHER THE VARIOUS THIN PANELS ACTING 3-D PLATES.

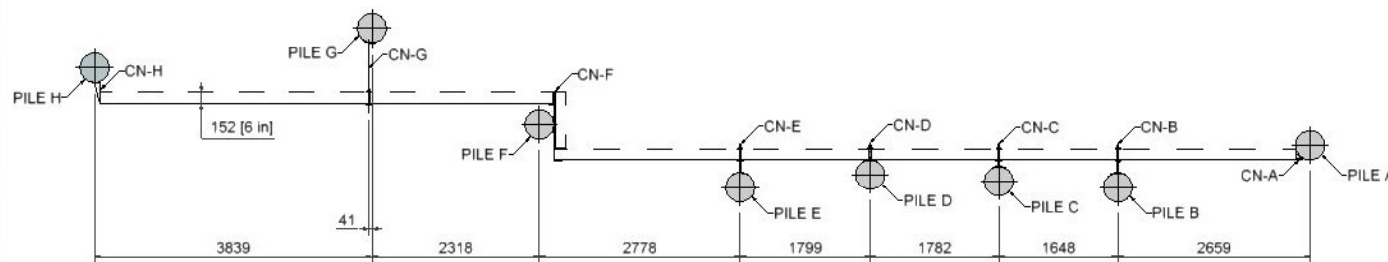
PLAN OF PILES LAYOUT

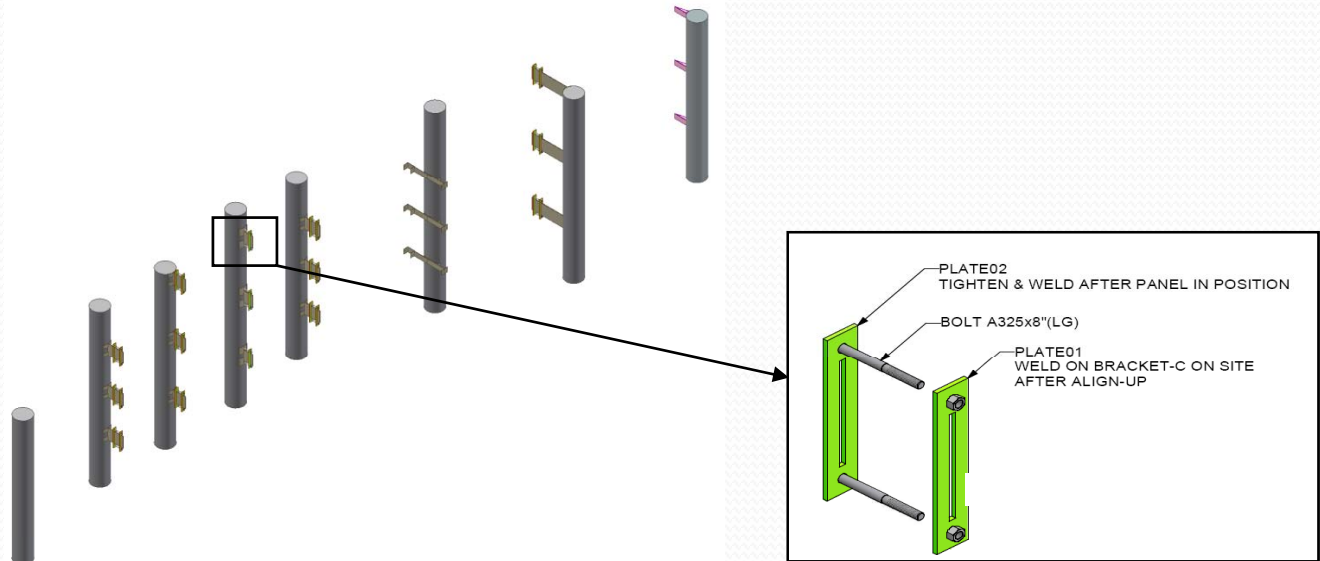
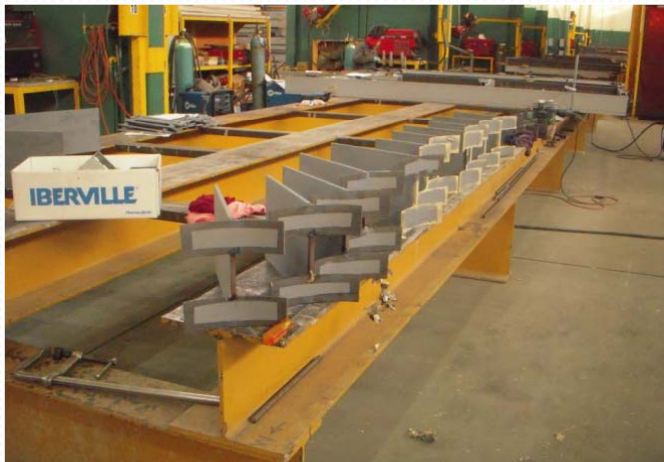
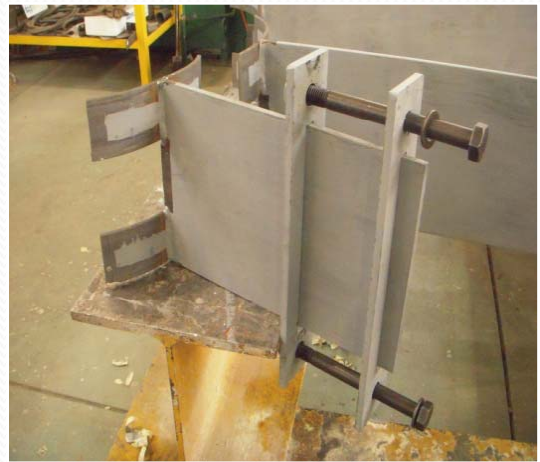
EACH IHI BRACKET WAS DIFFERENT DUE TO THE IRREGULARS FILE SPACING TO ACCOMMODATE THE OLD EXISTING INFRASTRUCTURE. TO OPTIMIZE THE INSTALLATION SPEED AND ACCURACY, SPECIAL VARIABLE AND ADJUSTABLE IHI BRACKETS WERE DEVELOPED AND MANUFACTURES AND UTILIZED.

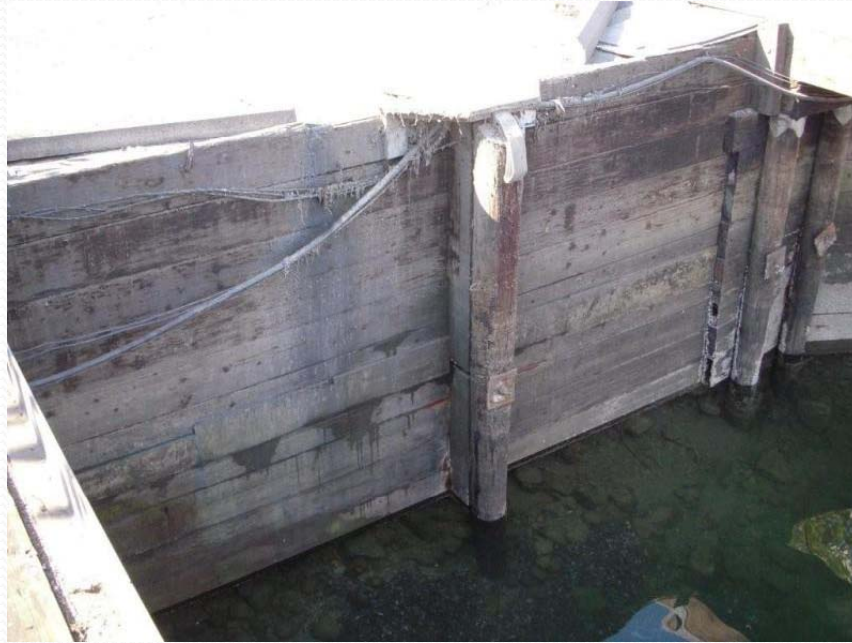
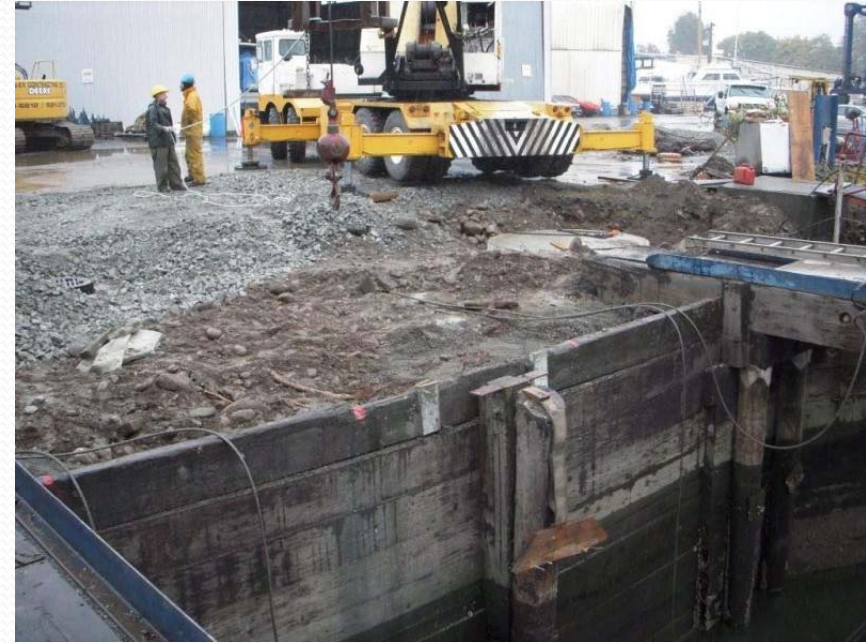
PICTURES OF THE SITE BEFORE SITE PREPARATION AND PRIOR TO THE INSTALLATION OF THE RETAINING SEA WALL

THE SOIL EROSION WAS ON-GOING, AND THE WOODEN WALLS WITH THE OLD PILING SYSTEM WAS AT AN END. THE KEY ISSUE WAS THAT WITHOUT INTERRUPTING THE EXISTING OPERATIONS A NEW VERY THIN IHI PANELIZED PLATES WERE INTRODUCED VERY SWIFTLY.

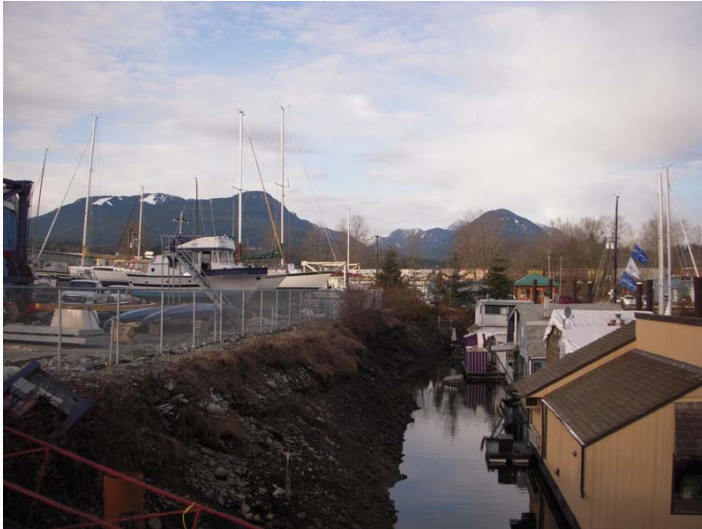
PHOTO OF SURROUNDING ENVIRONMENT SHOWING THE ON-GOING EROSION

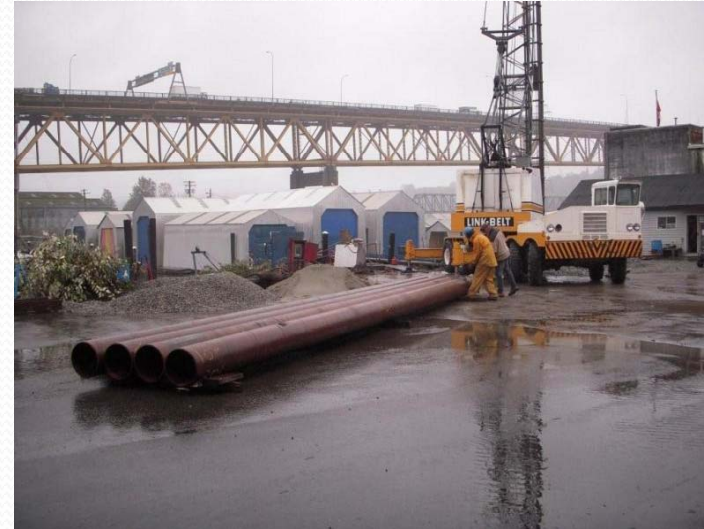
ARRIVAL OF STEEL PILES TO SITE

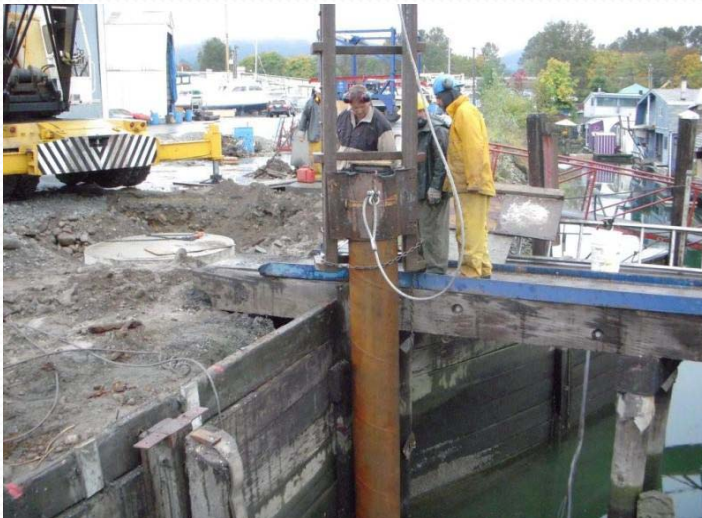
DRIVING PILES TO OCEAN BED

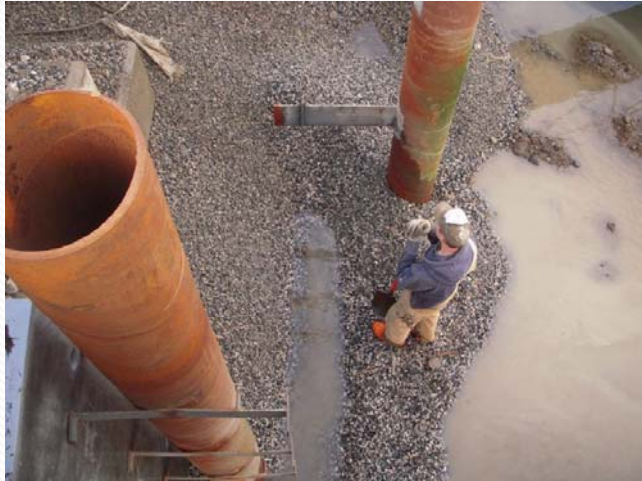
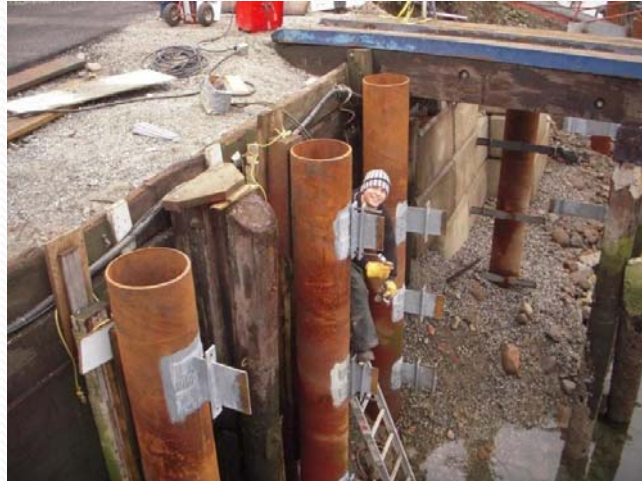
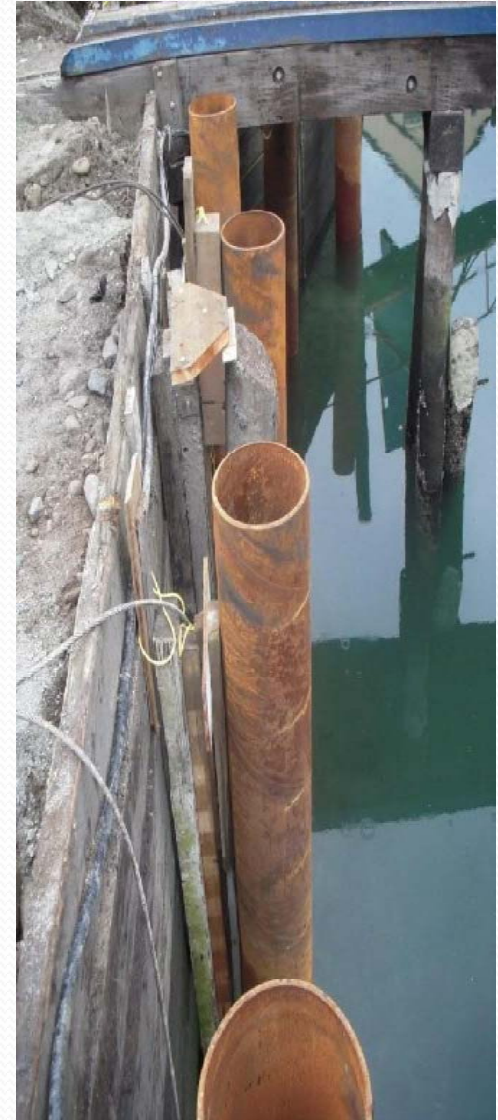
INSTALLATION OF STEEL PILES WITH SPECIAL WELDED BRACKETS, THIN AND ADJUSTABLE IHI BRACKETS TO CONNECT THE IHI PANELIZED PLATES.

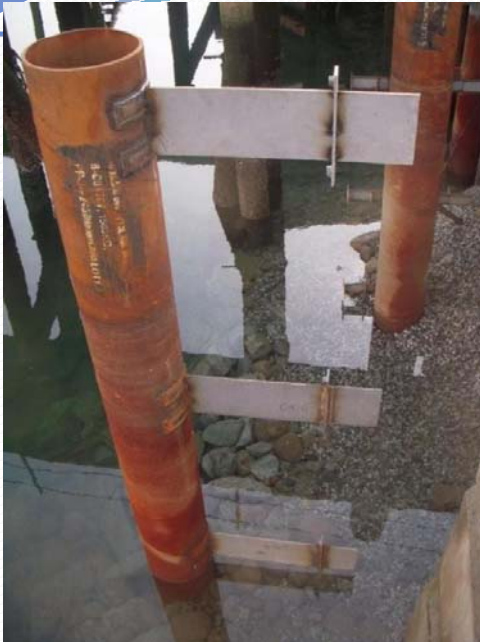
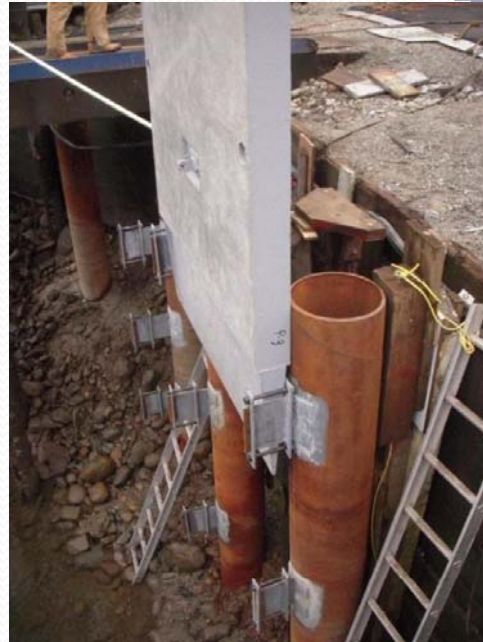
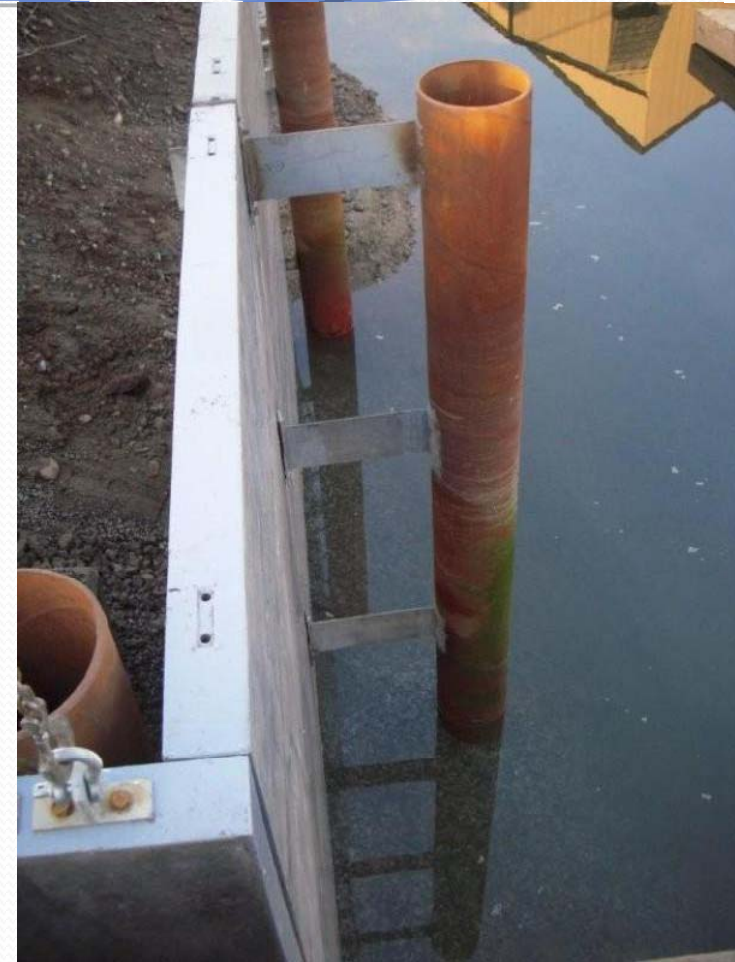
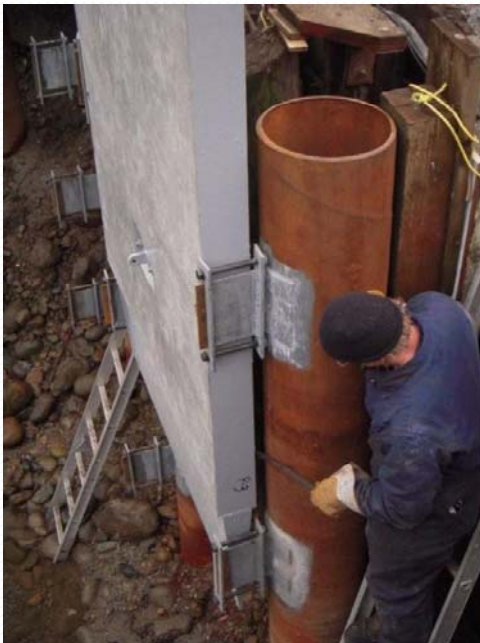
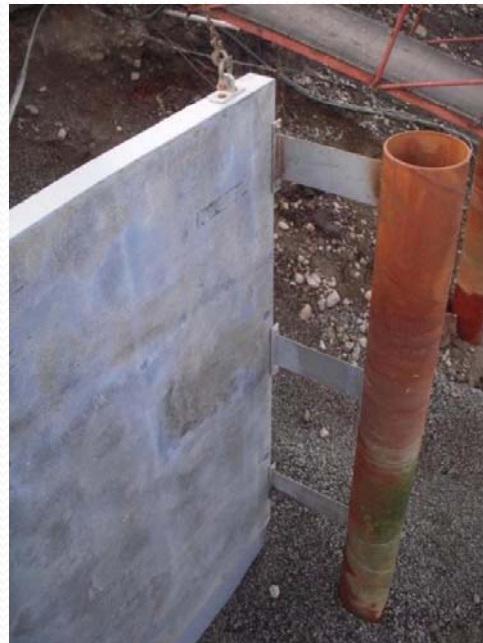
IN SPITE OF THE FACT THAT THE STEEL PILES (AS PREVIOUSLY MENTIONED) WERE NOT ALIGNED, PLUMBED AD UNIFORMLY SPACED, THE IHI PANELIZED PLATES WERE STRUCTURALLY CONNECTED AND ARCHITECTURALLY FIT.

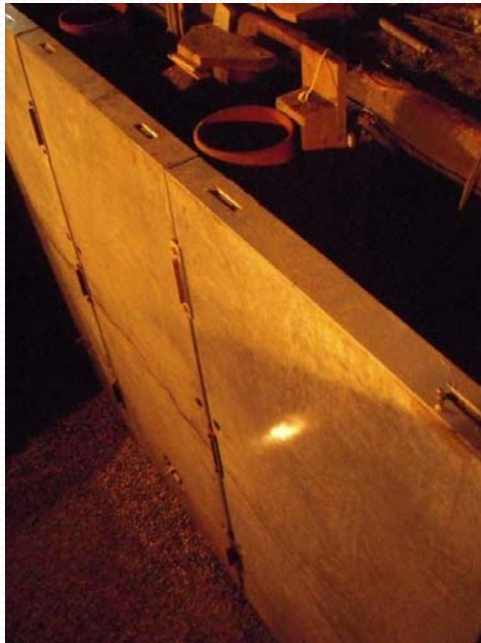
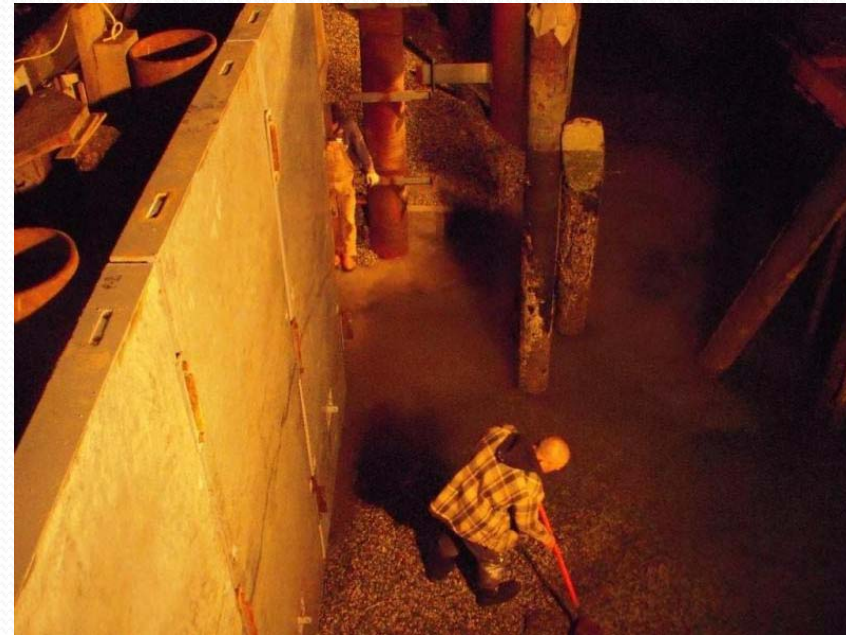
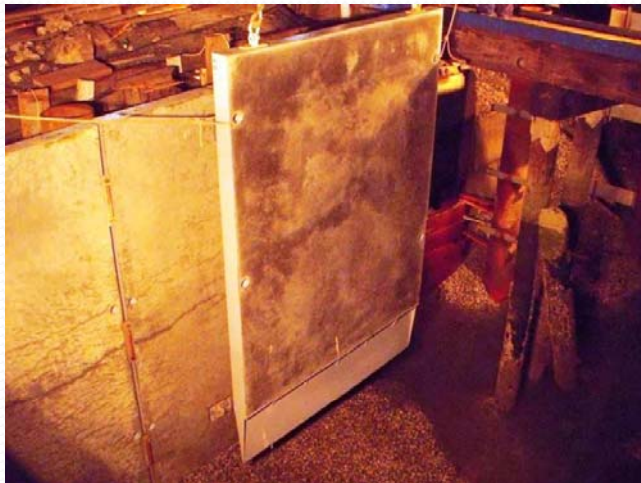
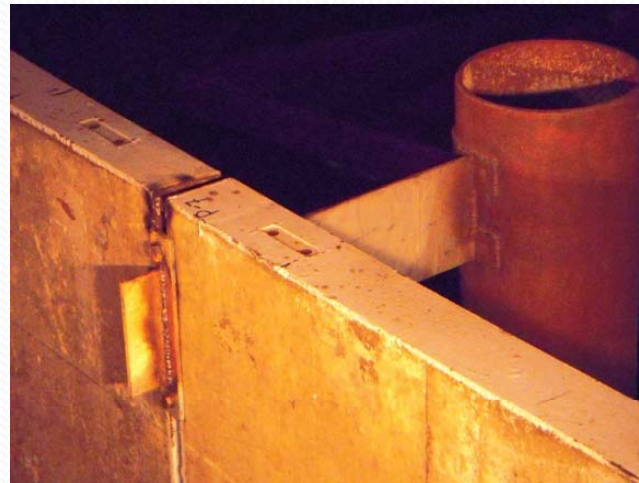
PHOTOS SHOW CREW WORKING AT NIGHT WHEN THE WATER TIDE IS LOW.

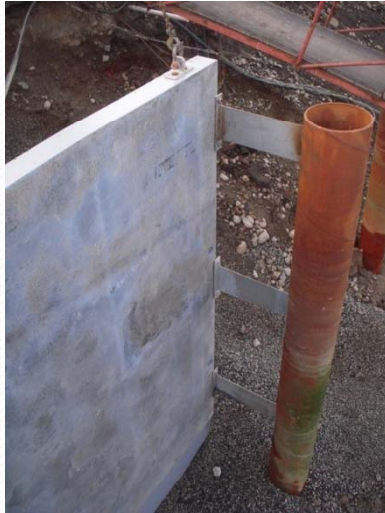
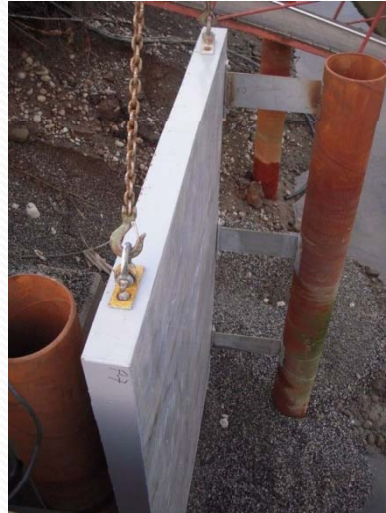
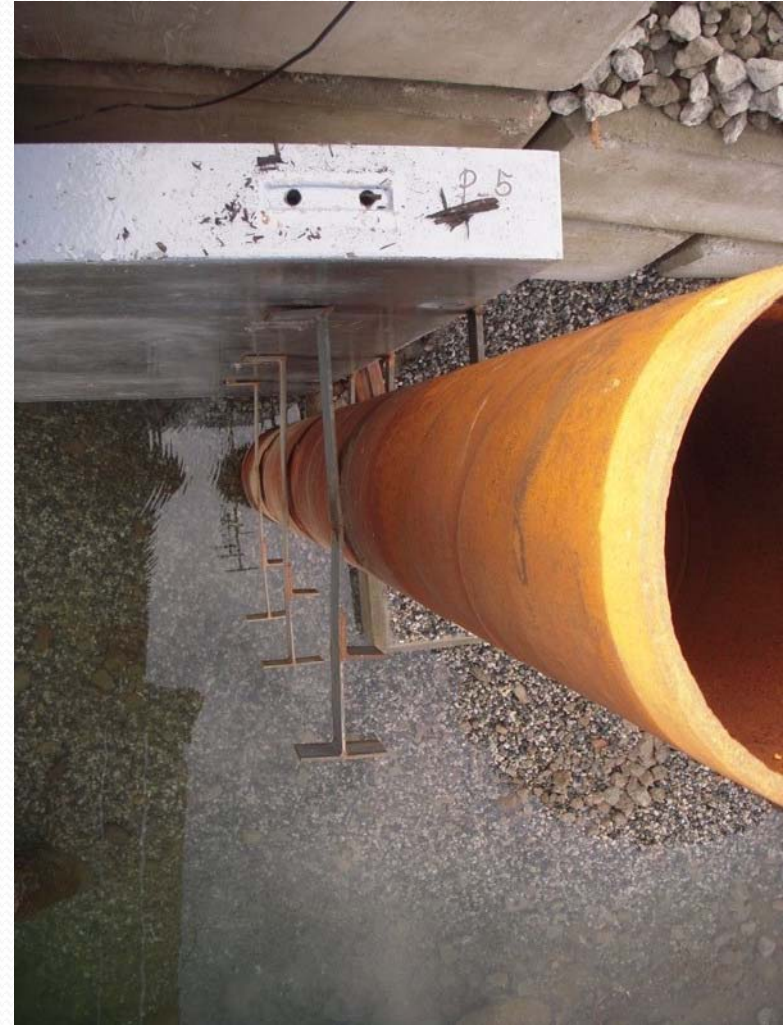
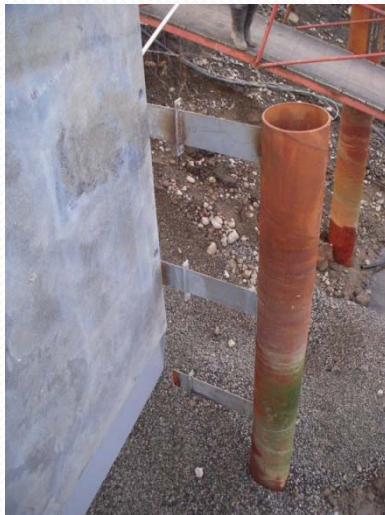
DUE TO THE SOFT GROUND AND THE IHI LIGHT WEIGHT PANELS THERE WAS NO NEED FOR A FOUNDATION RESULTING IN A FASTER INSTALLATION AND A LOWER BUDGET.

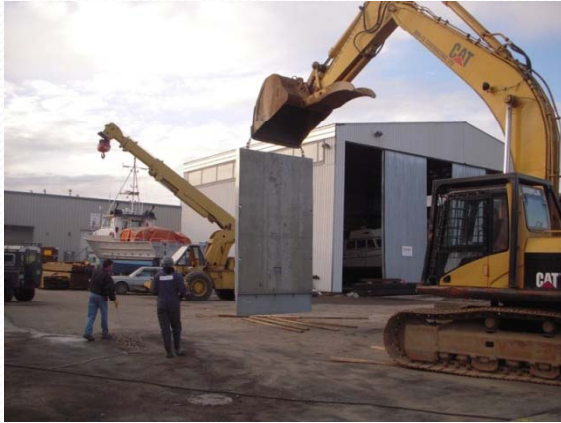
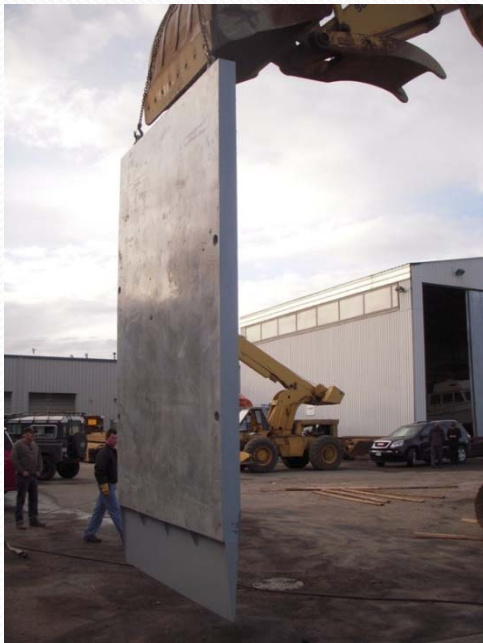
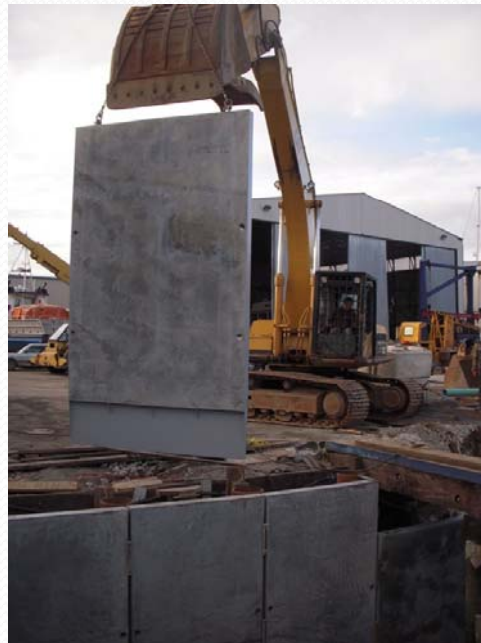
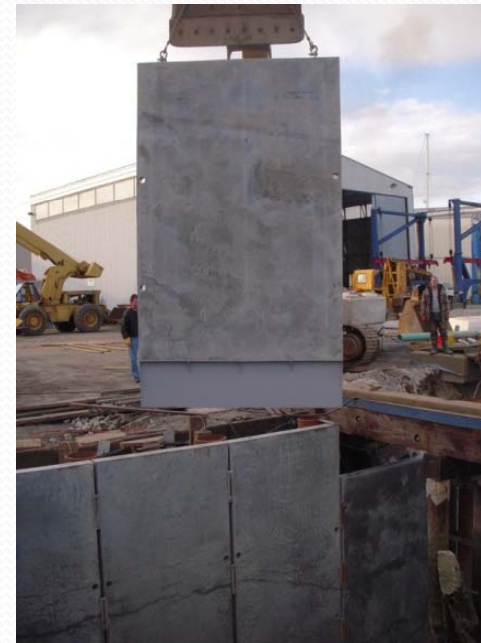
DUE TO THE FLEXIBILITY OF THE IHI SYSTEM, A BACKHOE WAS UTILIZED ON SITE TO INSTALL THE PANELS.

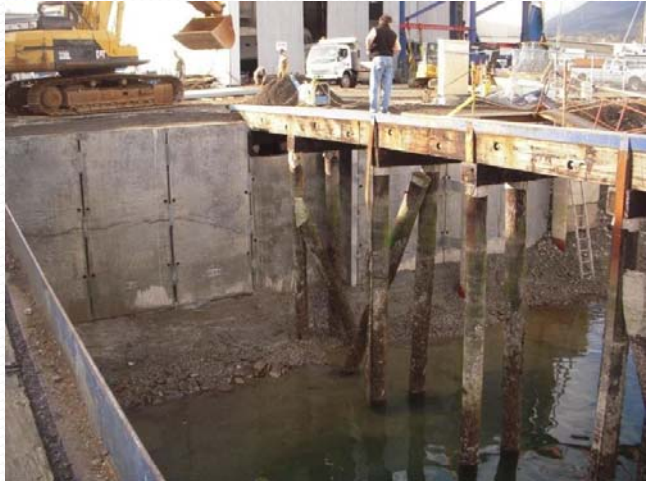
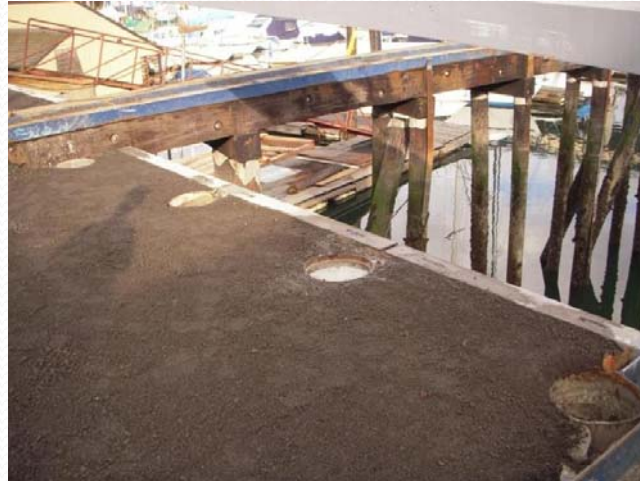
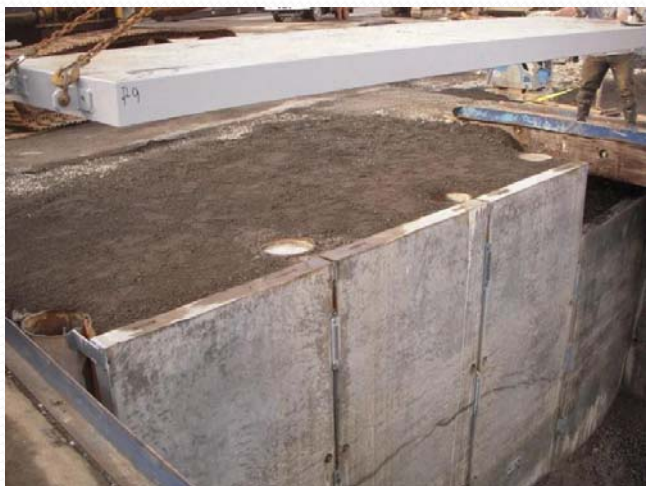
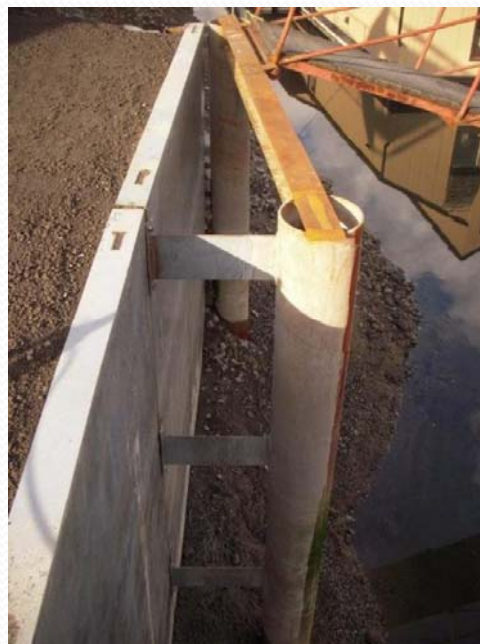
PROPER FILLED COMPACTION BEHIND THE IHI PANELIZED PLATES AFTER PLACING REINFORCED CONCRETE INTO THE THIN PILES FOR EXTRA RIGIDITY.

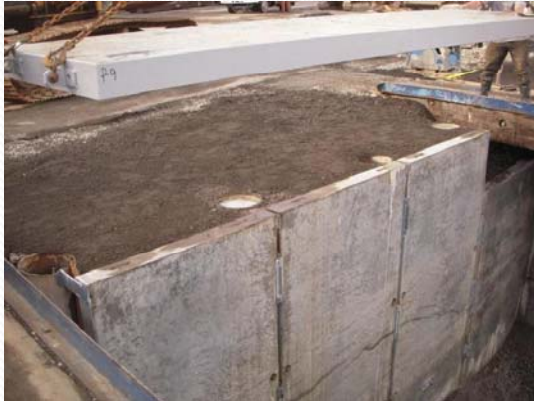
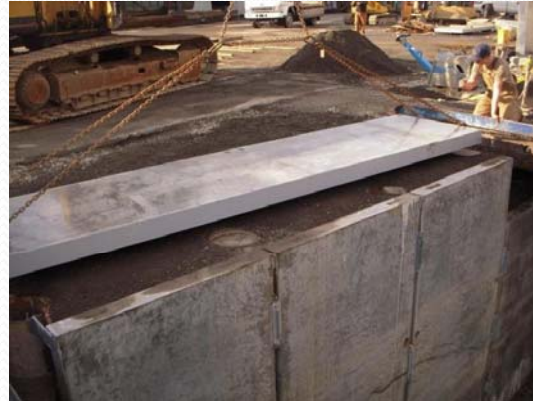
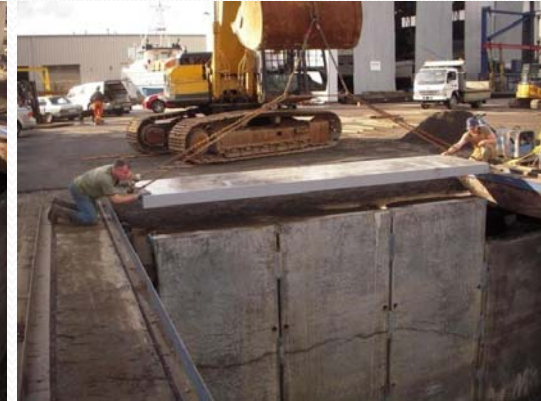
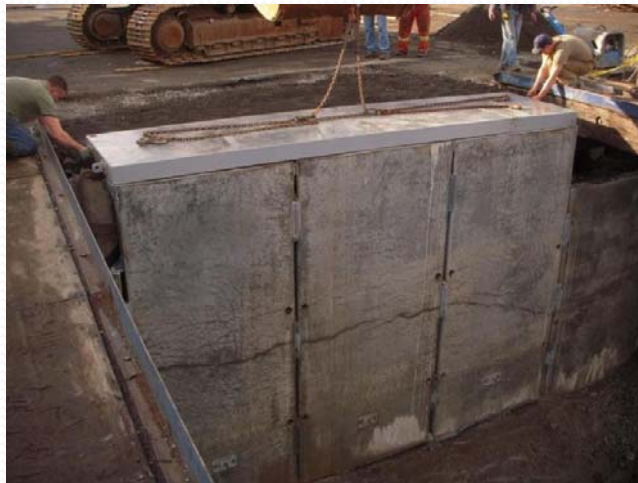
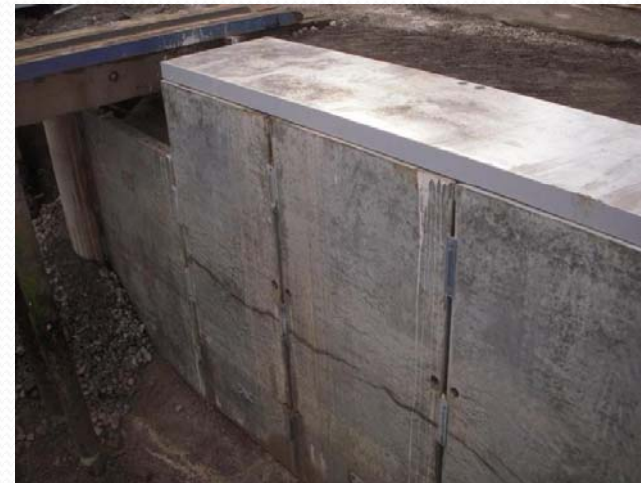
A NICE IHI HORIZONTAL PANELIZED PLATE WAS CAPPED ON TOP TO STIFFEN FURTHER THE VERTICAL PANELIZED PLATES. ELEGANT DRAINAGE SLOTS WERE INTEGRATED TO ALLOW FOR FAST WATER DRAINAGE BETWEEN HIGH AND LOW TIDE THAT CAN REACH APPROXIMATELY 5 METERS VERY RAPIDLY.

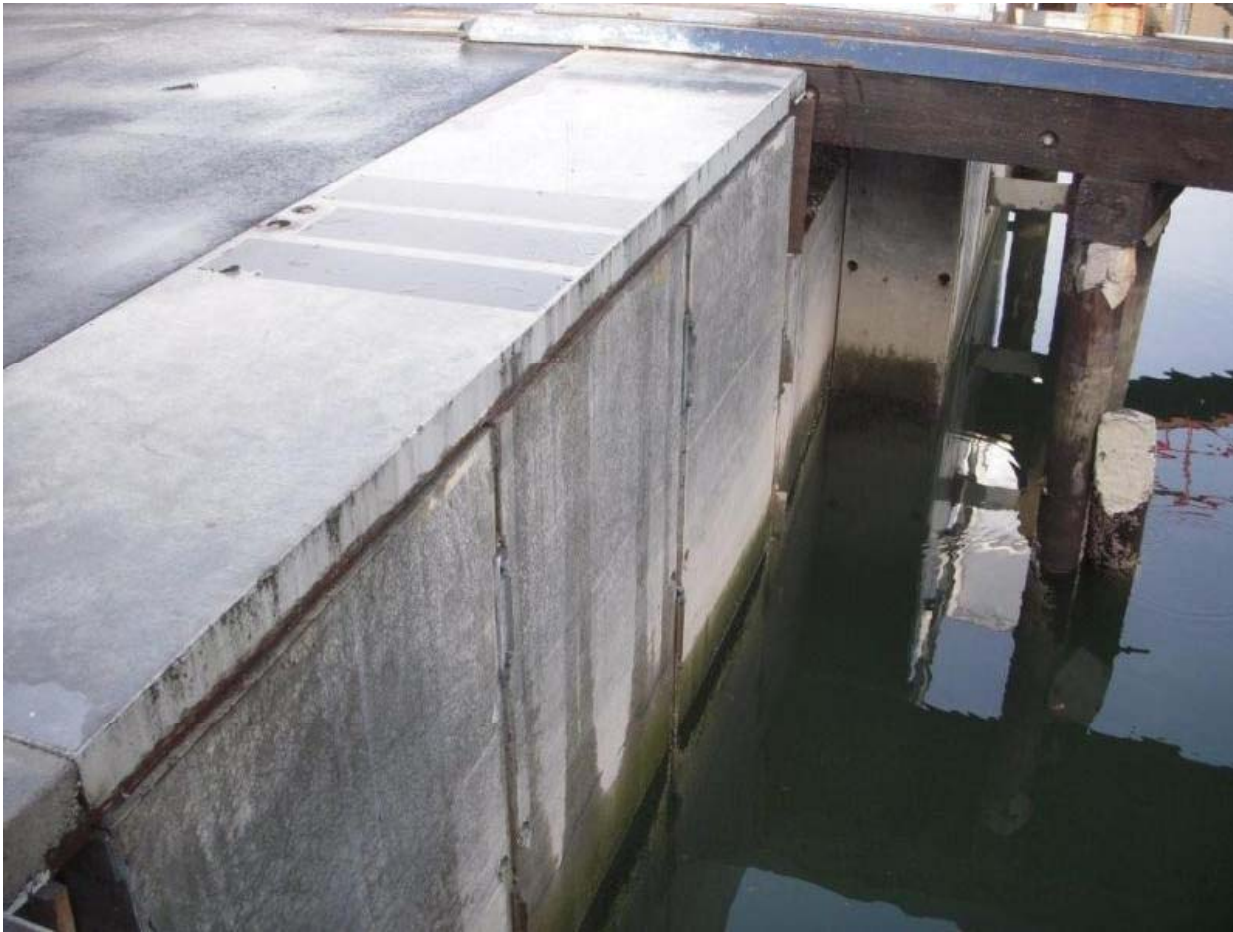
ONE YEAR AFTER COMPLETION, NO SIGN OF ANY RUST OR CONCRETE DETERIORATION DUE TO THE OCEAN (HIGH/LOW TIDES) SALTY WATER . EVERYTHING IS STILL AS IS FROM DAY ONE AFTER COMPLETION.

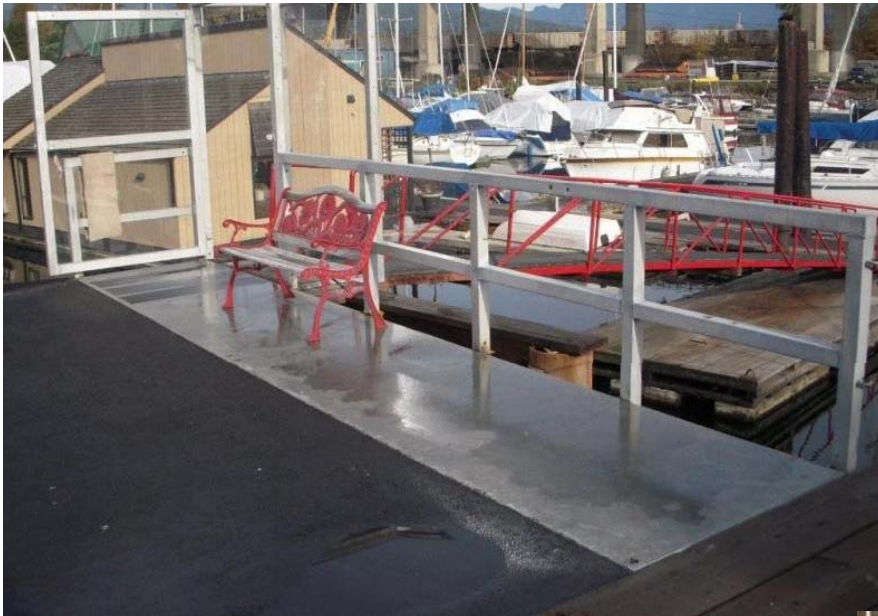
THOUGH THE IHI PLATES ARE VERY THIN, AND EVEN AFTER ONE YEAR, THERE HAS BEEN NO SIGN OF ANY DIFFERENTIAL SETTLEMENT IN SPITE OF THE FACT THAT THERE WAS NO FOUNDATION PLACED UNDERNEATH AS PER PREVIOUS SLIDE.
